Monitoring Data Record

Project Title: R-2552B Clayton Bypass COE Action ID: 200220745  
Stream Name: Site 5 DWQ Number: 041760  
City, County and other Location Information: US 70 Clayton Bypass from I-40 to US 70  
Station 82+60 to 85+50 -L-  
Date Construction Completed: 4/21/06  
Monitoring Year: ( 4 ) of 5  
Ecoregion: \_\_\_\_\_ 8 digit HUC unit 03020201  
USGS Quad Name and Coordinates: \_\_\_\_\_

# R-2552B Clayton Bypass

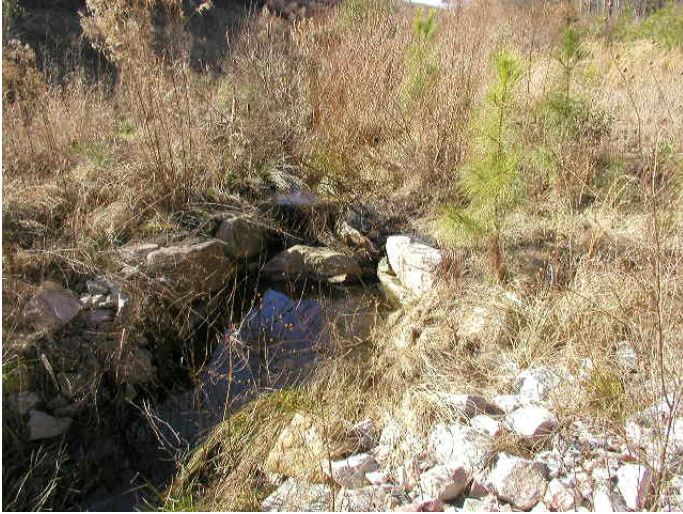
Photo Point #4 (Upstream)

The stream relocation is stabilized for the Year 4 Winter evaluation, except for some minor bank scouring on the right bank at Photo Point #4 (Sta. 11+10-S-). There is also some erosion at the inlet end of the box culvert around the right wing wall. NCDOT is planning to repair the area around the right wing wall in the near future. NCDOT will continue to monitor the channel stability at this stream relocation.

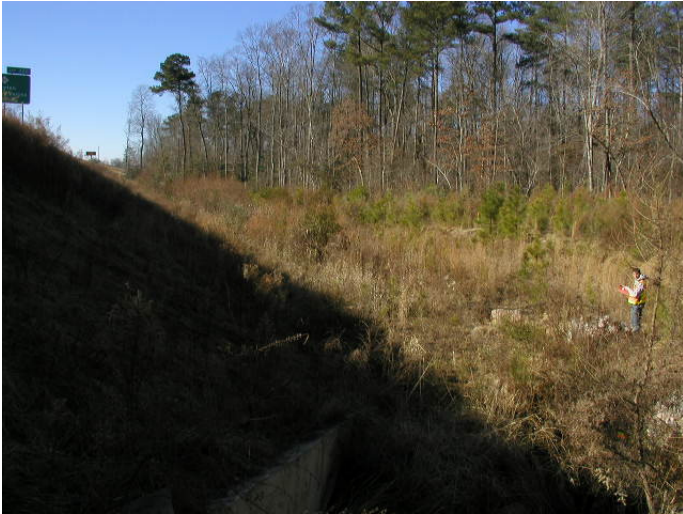
(Overview Photo of Site)

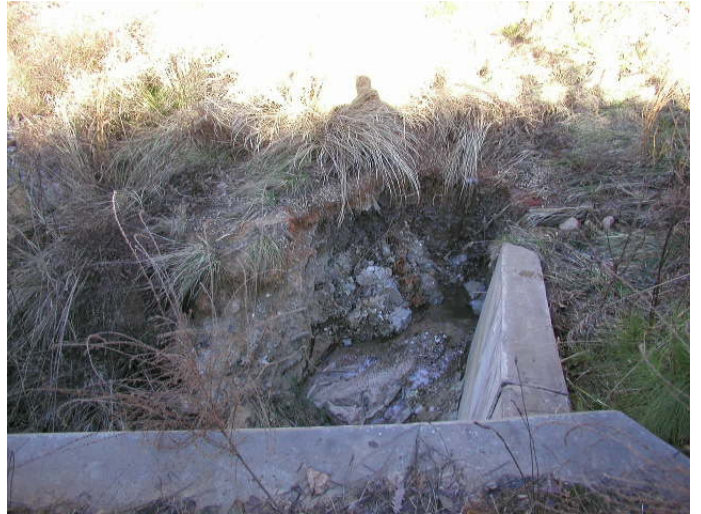
Erosion at inlet end of box culvert around right wing wall
